# Manhole Inspection Summary

Manhole # S47MM\_016MH

**Location** Address: **Gay**

Cross Street: **Montford**

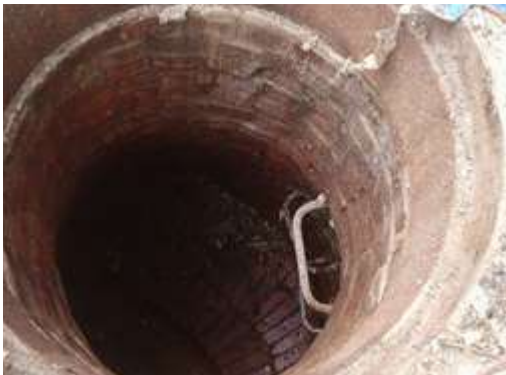
Defect 1

☒ **Leaks**

frame leaks

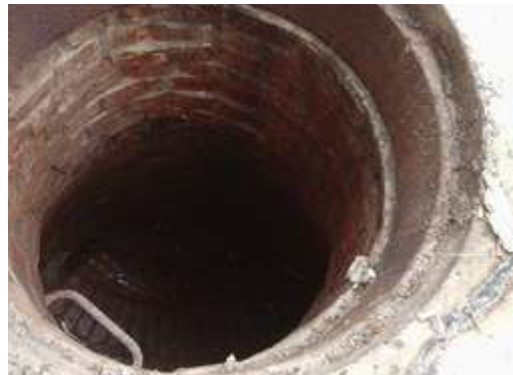
Defect 2

Infiltration: ☐ None ☒ **Joint** ☐ Cracks ☐ Mortar ☐ Roots ☐ Wall

Infiltration: ☐ None ☐ Joint ☐ Cracks ☐ Mortar ☐ Roots ☒ **Wall**

infiltration

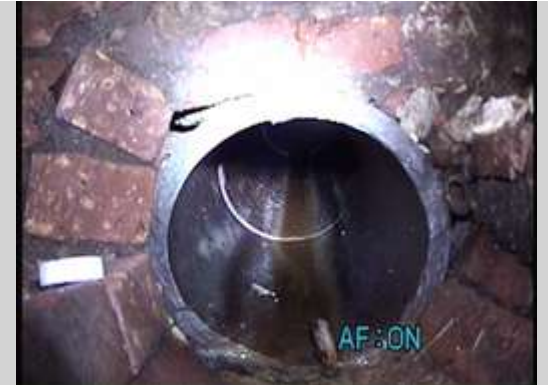
12 O'Clock Outflow

8 in. Circular Gravity Sewer  
Pipe Out @ 12 O'Clock

Pipe Height: **8.4** (in.) Rod and Bar (Angled)  
Pipe Material: **Clay** ☐ Pipe Lined  
Invert Depth: **7.95** (ft.) Flow Characteristics: **Fast**  
Deposits: ☒ None ☐ Mud ☐ Sludge ☐ Debris ☐ Grease  
Silt Depth: (in.) Deposits Extent:  
Infiltration: **None** Pipe Seal Cond: **Sound**

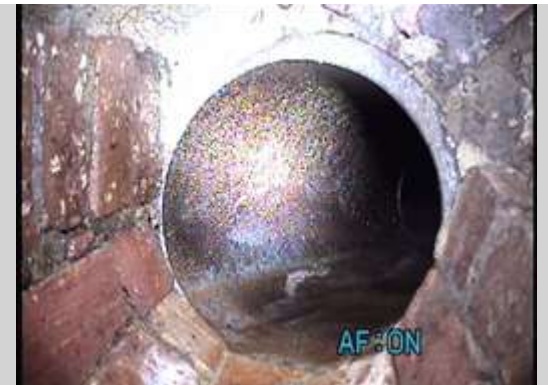
7 O'Clock Inflow

8 in. Circular Gravity Sewer  
Pipe In @ 7 O'Clock

Pipe Height: **8.4** (in.) Rod and Bar (Angled)  
Pipe Material: **Clay** ☐ Pipe Lined  
Invert Depth: **7.45** (ft.) Flow Characteristics: **Fast**  
Deposits: ☒ None ☐ Mud ☐ Sludge ☐ Debris ☐ Grease  
Silt Depth: (in.) Deposits Extent:  
Infiltration: **None** Pipe Seal Cond: **Sound**
